**The Great Salt Lake Causeway-  
Its Recent History and Current Maintenance Program**

**Abstract:**

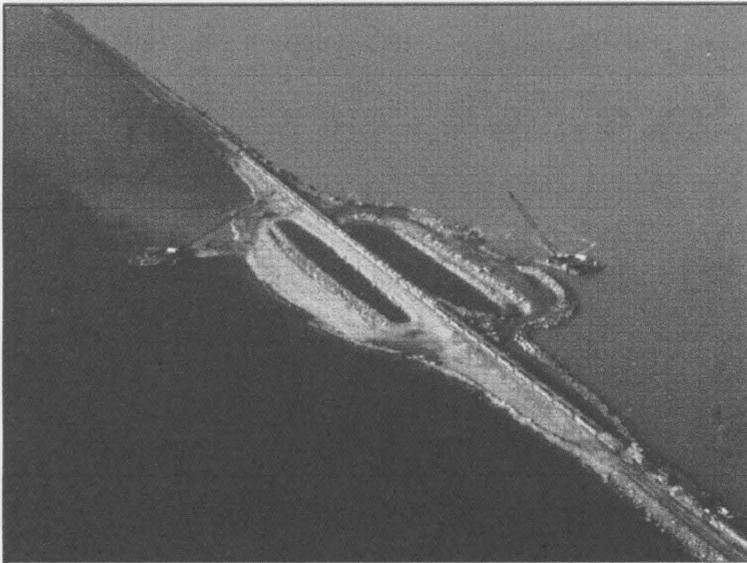
Figure 5- MP748 Final Berm Configuration

In early 1999, the area around MP748 was settling approximately nine inches per month and was being leveled regularly by the local surfacing crew. On 16 August 2000, a 1000-foot long section of the embankment at MP748 dropped 10 feet overnight. The UPRR was able to raise the track level four feet in one day to keep it above the water level, but over the next night, the track dropped down to water level again. The UPRR requested assistance from MPA, who identified the problem as a bearing capacity/lateral spreading failure.

After completion of the berms, MPA drilled three borings in the area to ascertain the cause of the failure. Based on the results of the borings, it appears that the salt layer, which was identified in the original design drawings of 1956 and in the borings from the early 1980's, is no longer present. It is suspected that the salt layer dissolved, which contributed to the failure, or broke into many pieces as a result of the failure. The actual failure mechanism is not fully understood at this time.

**Fig 5: MP748 Final Berm Configuration**

While the short-term solution of keeping the trains running across the GSL was accomplished, a permanent solution to stabilize this portion of the Causeway was being designed and sent out to bid. The solution consisted of constructing two massive, rock-filled berms, one north and one south of the failure area, to prevent additional movement. The construction of the berms began

on 12 Sept 2000 and was completed in late January 2001. The railroad partnered with the contractor to complete the work. The fill to construct the berms was delivered by two side dump car work trains, consisting of thirty cars each that came to the site twice per day, with two deliveries in the morning and two in the afternoon. Draglines, located on barges on each side of the causeway, spread the material out over the soft bottom sediments and excavators placed the armor rock on the outer edge of the berms for wave protection. Figure 5 is a photo of the final berm configuration.

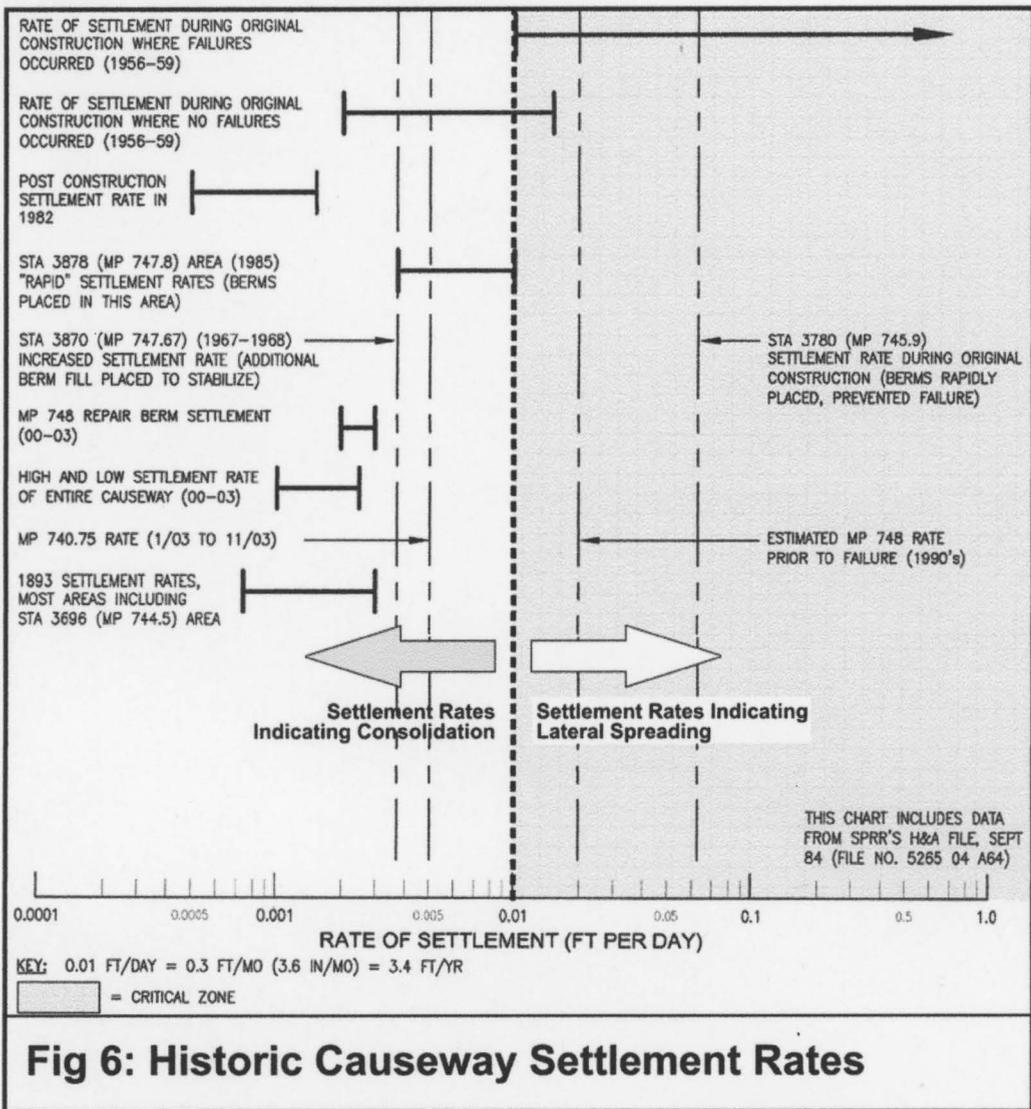
Figure 6- Historic Causeway Settlement Rates

Figure 6 is a compilation of historical settlement rates since the time of construction in the 1950's, showing the settlement rates which were known to produce failure of the embankment and those that didn't. If the rate is below 0.01 feet per day, or 3.4 feet per year, this settlement is considered consolidation. However, if the rate is greater than 0.01 feet per day, this is considered lateral movement, which could progress to an embankment failure. Counterweight berms, similar to those at MP748, would need to be constructed to reduce the lateral movement. The railroad is prepared to mobilize rapidly to construct these berms, if necessary.
